## Points

## Bone and Joint CT with Reduced Artifacts in the Presence of Orthopedic Hardware

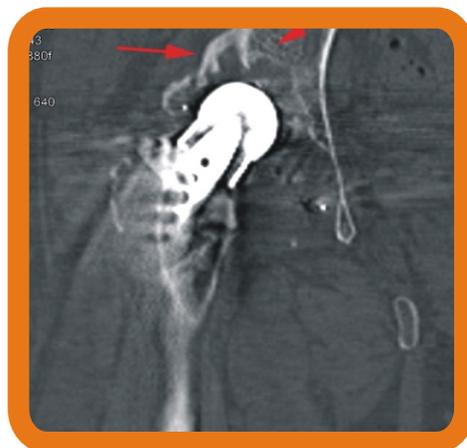
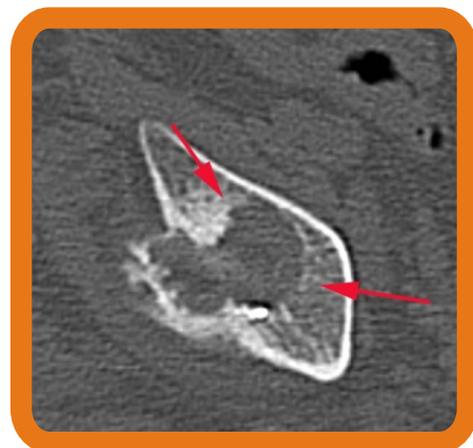
Fig. 1A

**Fig. 1(A,B):** Post total hip replacement (THR) acetabular osteolysis. This patient had pain 5-years following a THR. The plain radiographs were non-contributory. The coronal CT scan shows confluent osteolysis along the acetabular margin, the osteolytic areas communicating with the joint space (arrows). The axial image (B) shows this as well. The extent of osteolysis could be easily estimated on all the images.

1. Post-hip replacement acetabular osteolysis (Fig. 1)
2. Visualization of fracture union / non-union (Fig. 2)
3. Complications of instrumentation (Fig. 3)
4. Recurrence of disease (tumor, etc) (Fig. 4)

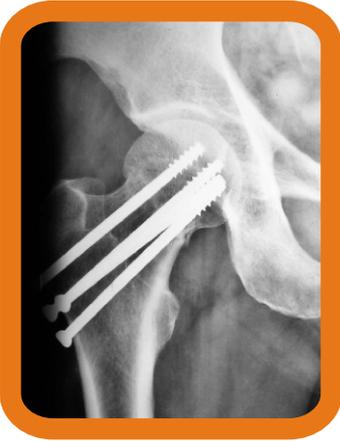
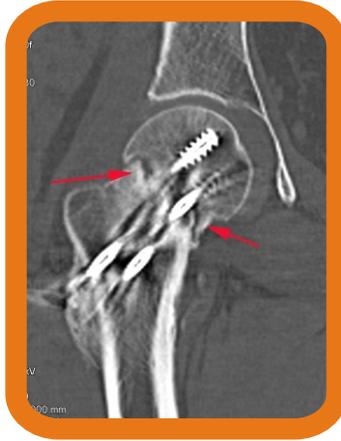
Fig. 2A

**Fig. 2 (A, B):** Non-united subcapital fracture. This lady, a year after surgery for a subcapital fracture of the femoral neck, had persistent pain. The plain radiography (A) was non-contributory. The coronal CT image (B), clearly shows the non-union (arrows)

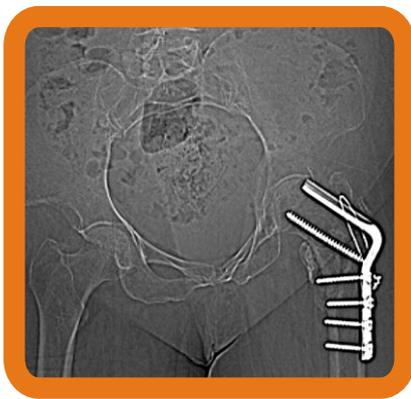
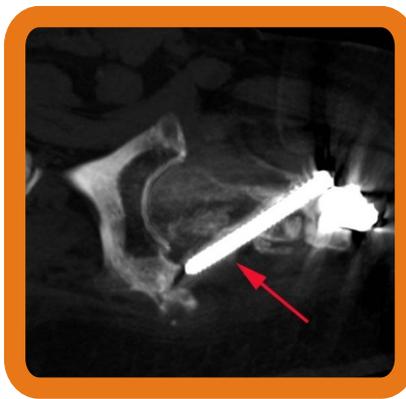
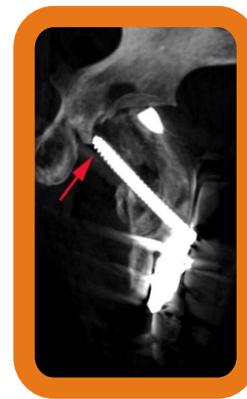
Fig. 3A

**Fig. 3 (A-C):** Improper screw placement. Following surgery for an inter-trochanteric fracture (A), the patient had persistent pain. Plain radiographs were non-contributory, so a CT scan was performed. The axial thick MIP (maximum intensity projection) image (B) shows clearly the position of the screw, which has obliquely cut through the posterior cortex. This is well seen on an oblique thick MIP image (C) as well.

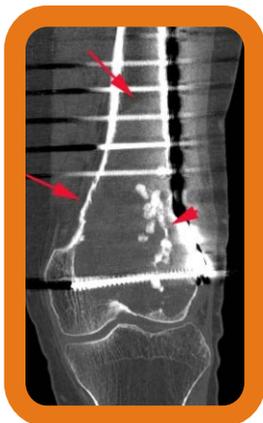
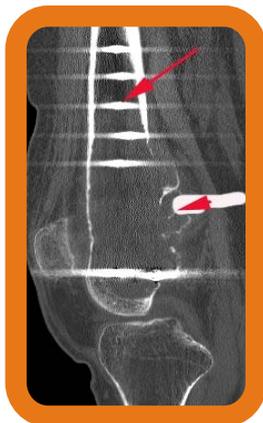
Fig. 4A

**Fig. 4 (A,B):** Recurrent giant cell tumor (GCT) of the femur. This 32-years old man who had been operated for a GCT of the femur with enucleation, grafting and instrumentation, presented with pain. Since an MRI would have yielded no information whatsoever, a CT scan was performed. A coronal image (A) clearly revealed an expansile, osteolytic lesion, with a sharp clear superior margin, marking the tumor extent. The bone fragments from the early bone graft were seen within the recurrent tumor (arrowheads). The sagittal image (B) also clearly showed the tumor margins (arrow), along with the posterior cortical thinning (arrowhead).
