Avascular Necrosis of the Femoral Head

WELLSPRING | Jankharia Imaging

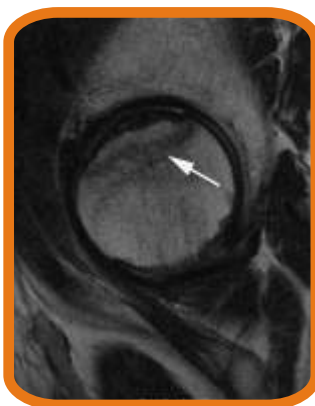
Fig. 1

Fig. 1: AVN. High-resolution T2W sagittal MRI of the femoral head shows a crescentic lesion (arrow) involving the antero-superior aspect of the femoral head.

In its earliest phase, AVN presents as an area of crescentic altered signal, most commonly seen in the antero-superior aspect of the femoral head (Fig.1). It is usually accompanied by marrow edema, which suggests an active lesion. The extent of marrow edema usually correlates with the level of pain. The lesion itself may have varying signal intensity. The presence of fat signal intensity normal implies a stable lesion (Fig. 2) and is rarely accompanied by marrow edema.

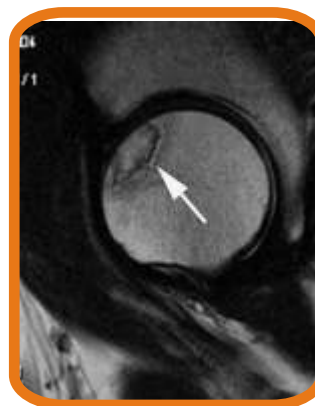
Fig. 2

Fig. 2: AVN. High-resolution T2W sagittal MRI of the femoral head shows a crescentic fat-containing lesion (arrow) involving the antero-superior aspect of the femoral head. This represents a stable lesion.

There are many staging systems. The main philosophy is to differentiate lesions that have already collapsed (Fig. 3) from those that have not (Fig. 2). Those where collapse has not occurred may be salvaged and controlled by aggressive medications and core decompression procedures. Once collapse has occurred, generally a total hip replacement is the only solution for a permanent cure.

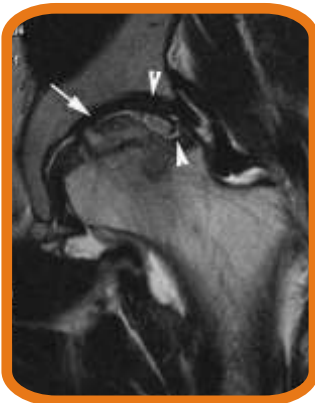
Fig. 3

Fig. 3: AVN. High-resolution T2W coronal MRI of the femoral head shows collapse with loss of contour (arrow) and areas of fragmentation and subchondral fracture (arrowheads).

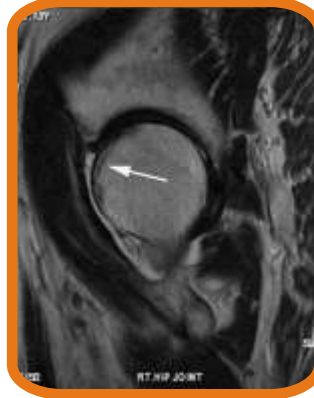
Fig. 4

Fig. 4: Insufficiency fracture. T2W sagittal MRI of the femoral head shows a curvilinear subchondral hypointensity, paralleling the articular surface (arrow).

1. Insufficiency fracture (Fig. 4): This is not an uncommon entity and in the earlier days before high-resolution MRI was often mistaken for transient osteoporosis of the hip (TOH). A curvilinear area is seen paralleling the femoral head, and is associated with marrow edema.
2. Transient osteoporosis of the hip (Fig. 5): This is an ill-understood condition, most common in pregnant or post-partum women, where there is sudden marrow edema in the femoral head, without a focal crescentic or curvilinear lesion. It is self-limiting with rest.

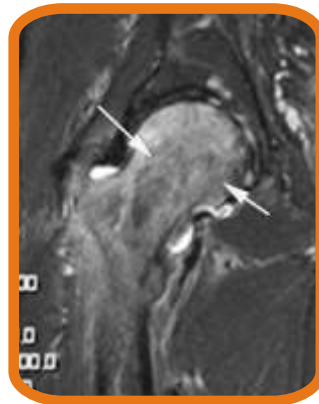
Fig. 5

Fig. 5: Transient osteoporosis. STIR coronal MRI of the femoral head shows extensive marrow edema (arrows) without a focal lesion in a post-partum 29-years old lady, which resolved after six months.
